Title: *Reuse of Waste Tyre Fibres in Concrete - Fire-Spalling Mitigation*

ABSTRACT

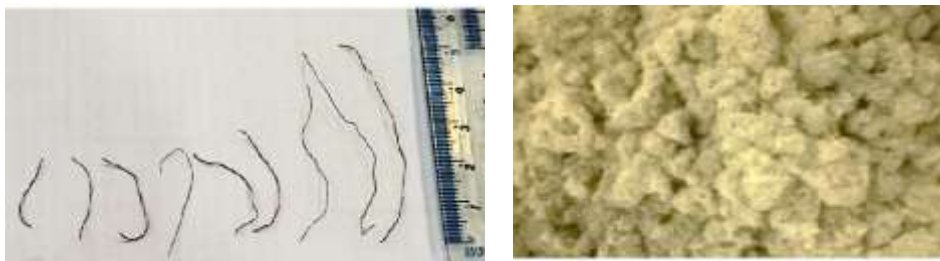
Figure 1. Reused tyre steel fibres (left) and reused tyre polymer fibres (right) after cleaning

Currently, polymer fibres extracted from tyres are too contaminated with rubber and too tangled to be reused as a construction material. Techniques for removing rubber contamination and separating tangled filaments for the large-scale production of RTPF do not exist. In this research, a screening technique (using vibrating sieves) was employed to remove the majority of rubber dusts and particles for the purpose of laboratory testing. In addition, RTPF was integrated into concrete by manually sieving them into concrete then mixing the tangled fibre (remained on top of the sieve) in water with electric mixer, which was proven sufficient to uniformly disperse RTPF in the concrete mix for lab application. RTSF and RTPF used in the experimental testing are shown in Figure 1.

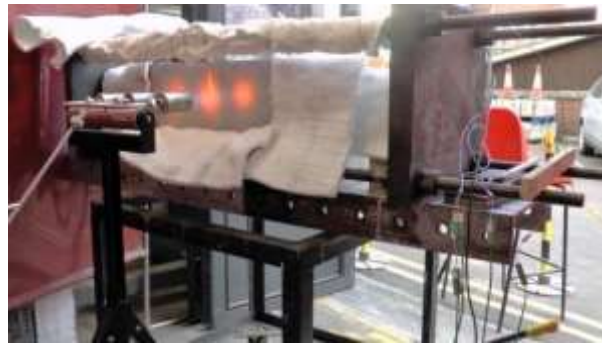
Figure 2. Test setup

The specimens were heated using a three-headed blowtorch. The distance of the blowtorch from the sample (i.e. 20cm) has been previously determined by Huang, et al [13] to reproduce an initial heating rate as close to that of a large pool hydrocarbon fire as possible [14]. A thermocouple was placed at the centre of the specimen's surface to measure the temperature of the fire during each test. Figure 2 shows the test set up.

During the spalling tests, the specimens were subjected to a constant load of 6.25MPa, 9% of the ambient-temperature compressive (cube) strength. During heating, the thermal expansion along the loaded axis was restrained and any changes in compressive stress were recorded throughout testing.

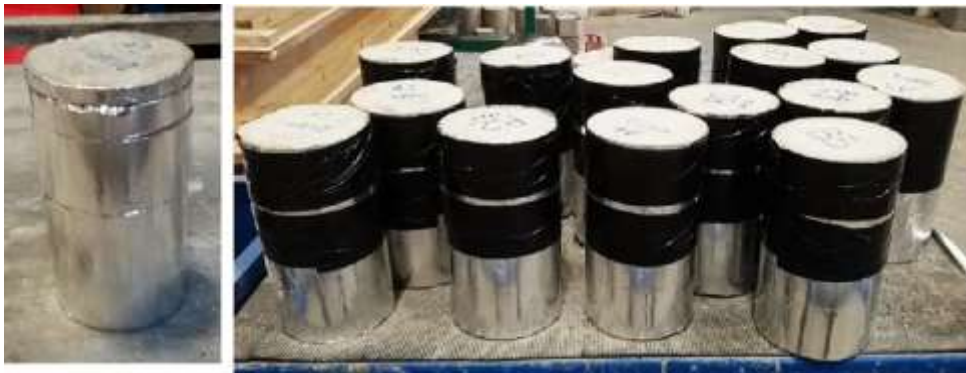
Figure 3. Cutting of cylinders (left) Wrapping of cylinders (right)

A primary cause of the fire-induced spalling of concrete is the inability of trapped moisture to escape from concrete pores [5]. Therefore, sixteen cylinders were cast in order to monitor moisture content in the specimens at different depths and time. For each concrete mix, four cylinders were prepared and subjected to the same curing condition as for the specimens. After being taken out of the mist room, all cylinders were cut at depths of 10mm, 20mm, 50mm and 100mm. One cylinder of each mix was dried in the oven for 24 hours at 100°C for the determination of the initial moisture content. The other three cylinders (for each mix) were then sealed with aluminium foil tape to provide one-dimensional drying condition. Plastic tapes were used to seal the gaps between the adjacent layers, as illustrated in Figure 3. Then the change in moisture content with time was monitored by weighing each slice daily.

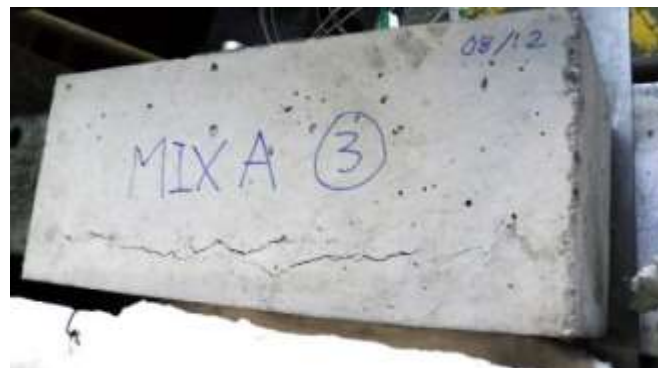
Figure 4. Large crack on top of specimen PC3

A summary of the test results is given in Table III. The aftermath of the spalling tests are shown in Table IV. Two of the three plain concrete specimens experienced severe spalling with a maximum depth of spalling up to 14mm. The other plain concrete specimens did not spall but a large crack extended on the top of the, as shown in Figure 4, which could help relieve pore pressure and explains why this specimen did not spall. The three specimens (SFC1, SFC2 and SFC3) with only RTSF barely spalled with very shallow spalling depth (around 1mm). This implies the incorporation of RTSF may not be able to stop fire-induced spalling completely but has the potential to control it. One of the three specimens (SF2PFC1, SF2PFC2 and SF2PFC3) with RTSF and 2kg/m³ RTPF spalled. It is worth noticing that the spalled concrete was still attached to the specimen surface as they might be held by the steel fibres. None of the

When spalling occurs, a sudden drop of temperature was captured. For instance, in the PC1 section of Figure 5, the measurements from the thermocouples at depths 1mm and 10mm indicate sudden decreases of temperature when spalling occurs. This is because they were both exposed directly to fire after explosive spalling occurred and so they no longer measured the temperature of concrete but that of the fire. Similar observations were made from the PC2 specimen. Note that a drop of temperature was also measured by the thermocouple at 10mm depth in PC3 specimen at 3 minute, which might be related to the development of internal cracks, triggering the development of the large crack on the top of the specimen, as shown in Figure 4.

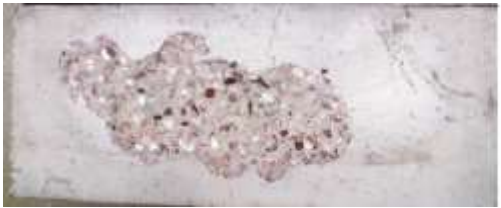
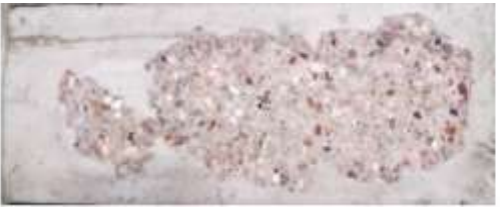
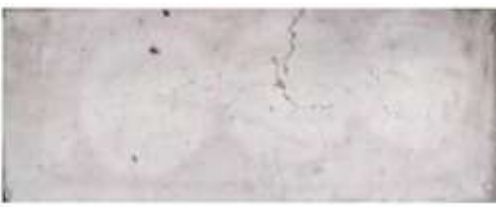
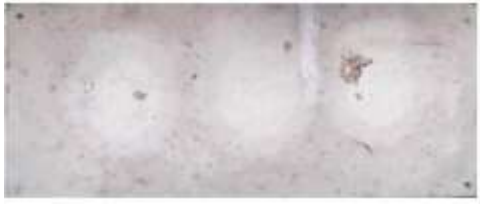
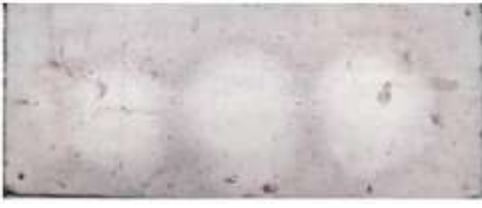
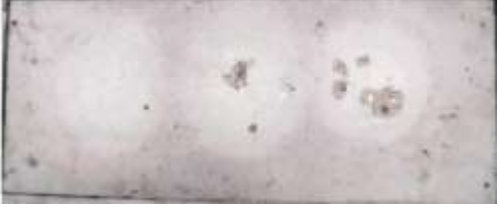
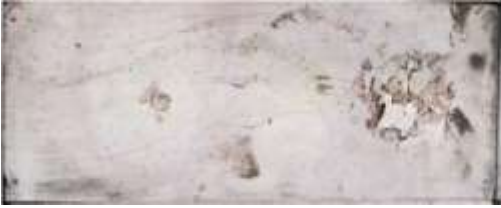
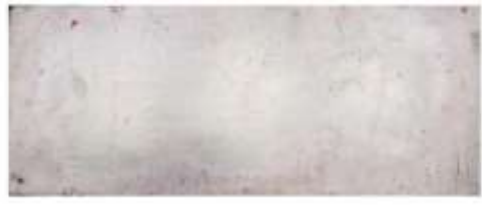
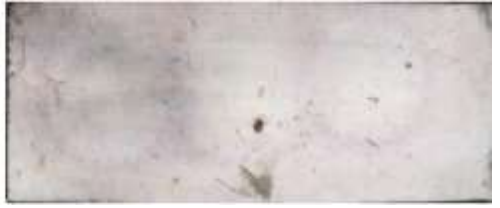
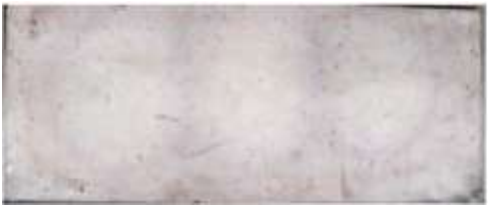
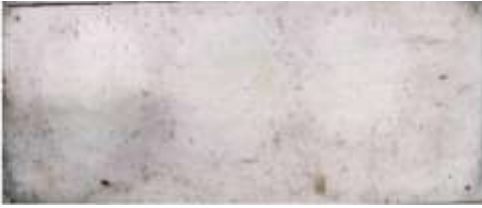
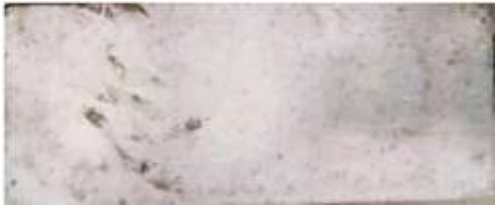
TABLE IV. SPECIMENS AFTER FIRE- INDUCED SPALLING TESTS

three specimens with RTSF and 5kg/m³ RTPF (SF5PFC1, SF5PFC2 and SF5PFC3) experienced spalling. In fact, there was barely any surface spalling that the specimens look almost intact after the fire test.

These results are encouraging in showing that RTPF has a potential to replace manufactured fibres for the mitigation of fire-induced spalling. The time taken for initial spalling to occur ranges from 41secs to 1min 12sec. The quantity of spalling was approximated by the measured weight change of the spalled specimens before and after the spalling tests, from which the moisture loss of un-spalled specimens due to heating is deducted, as listed in Table IV. Further research is required to investigate the contribution of reused tyre steel fibres in preventing fire-induced spalling, as well as to determine the optimum amount of RTPF required to protect concrete specimens from fire-induced spalling.

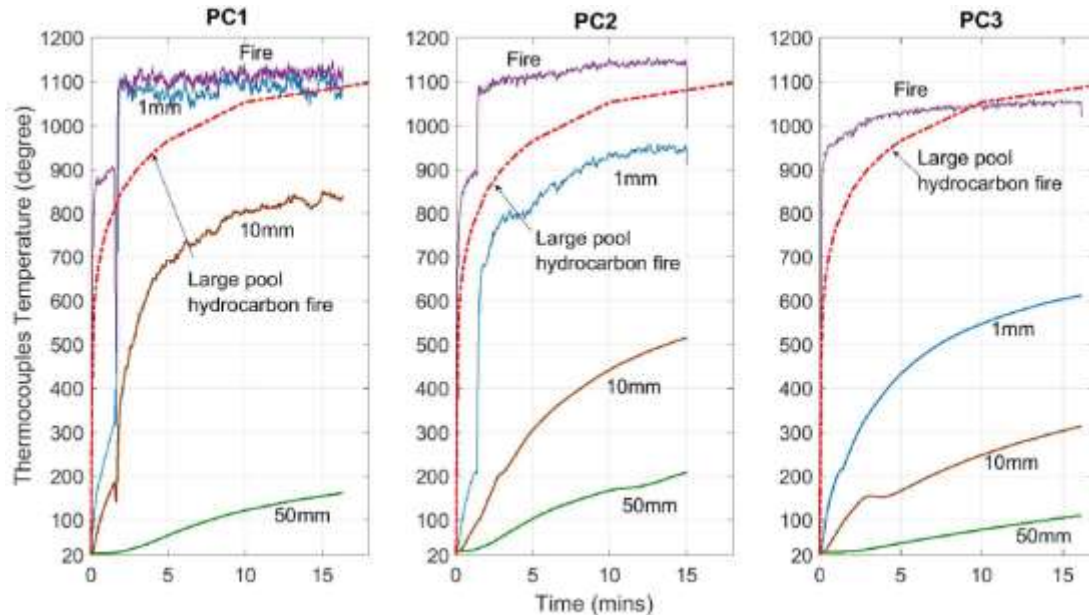
Figure 5. Temperature time curve of thermocouples & large pool hydrocarbon fire curve of PC1, PC2 and PC3

Thermocouples were used to measure the fire temperature very close to the heated surface of the specimen during the tests. Figure 7 plots the temperature-time relationships measured by all thermocouples. The large pool hydrocarbon fire curve is also plotted on this figure to allow comparison. A higher initial heating rate was achieved by using the blowtorch comparing with the large pool hydrocarbon curve.
